Vacuklav®23-B
Vacuklav®31-B

MELAG

Program-cycle / Diagnosis-program

Vacuklav®: 24-B / 30-B / 31-B
Euroklav®: 23-S / 23V-S / 29-S / 29V-S

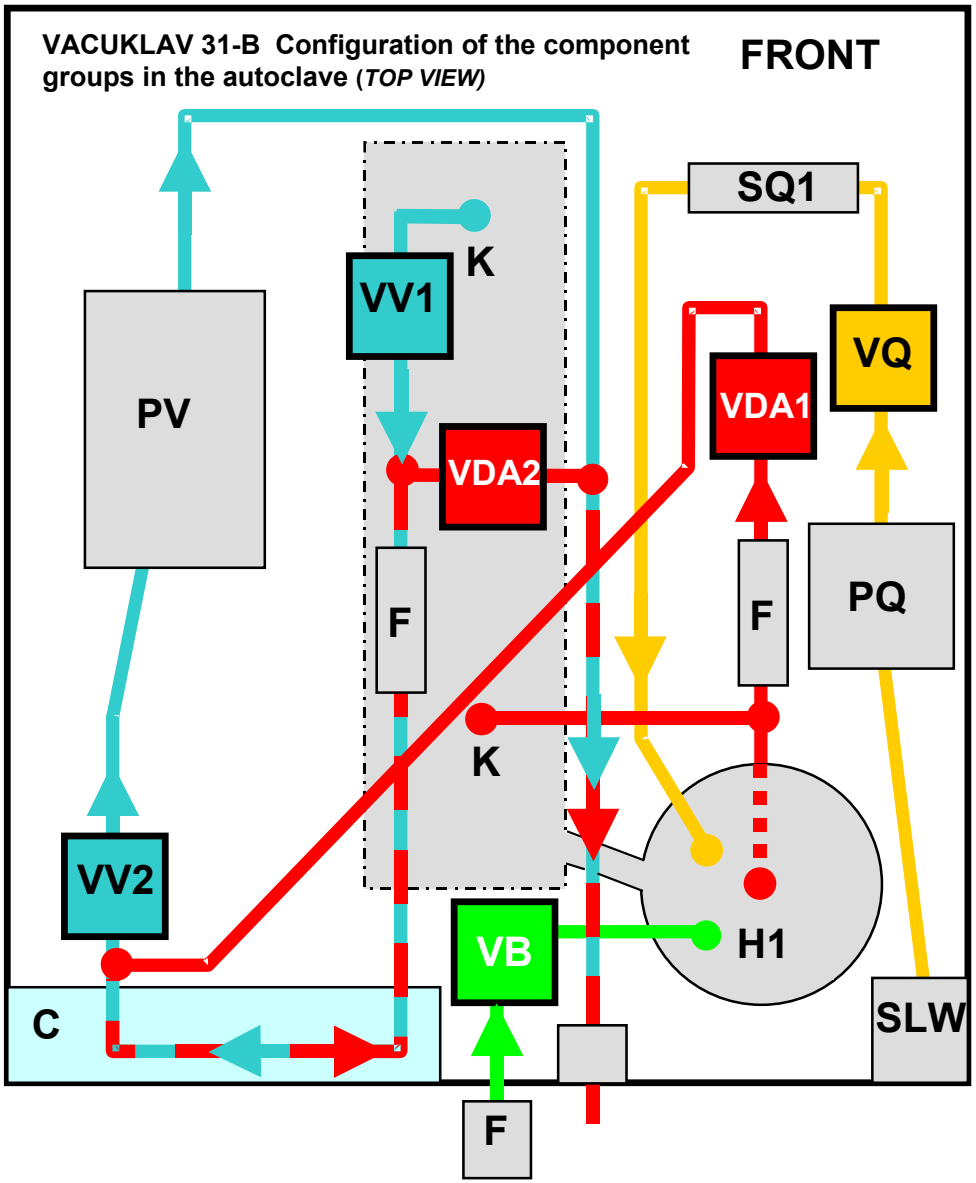
CONFIGURATION OFCOMPONENT GROUPS IN THE AUTOCLAVE
ERROR 1 VACUUM UNIT

The actual piping plan is contained in Drawing No. 31B-010.
This overview shows a rough schematic of the spatial configuration of the component groups, pipes, and hoses, in the Vacuklav® 31-B. The following error descriptions will refer to this overview to help you find the component groups to be checked.

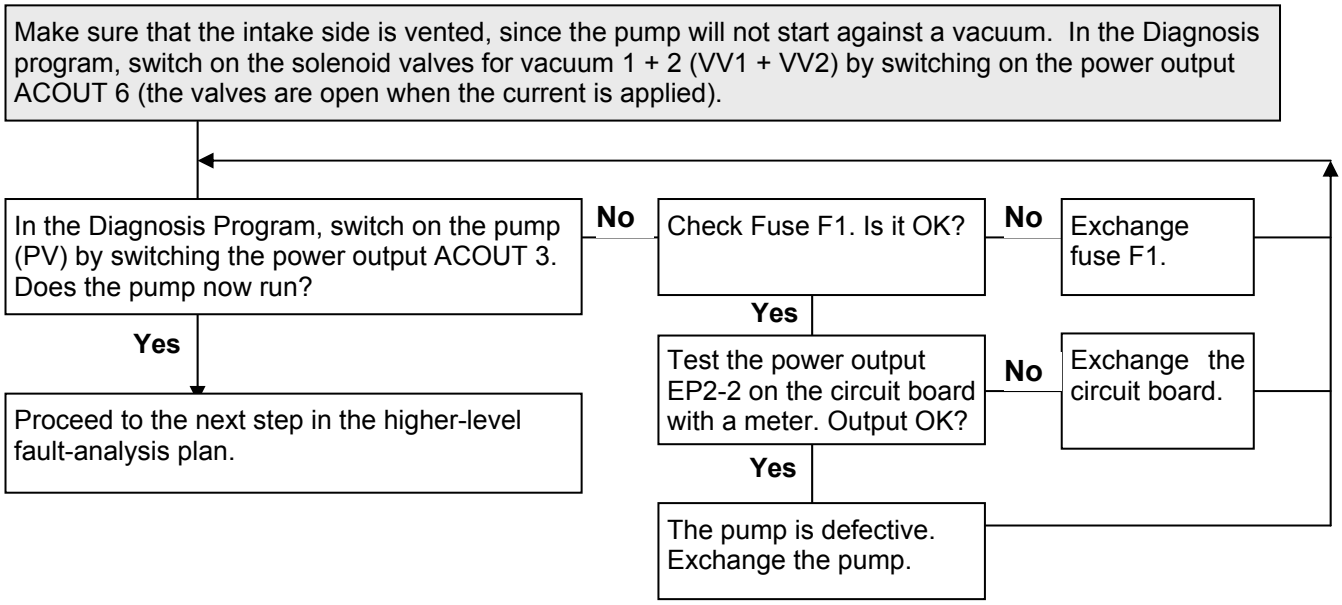
→ Fault class: Fault in control system or function of the pump

You can check the input voltage for the vacuum pump, as well as the function of the pump, as follows:

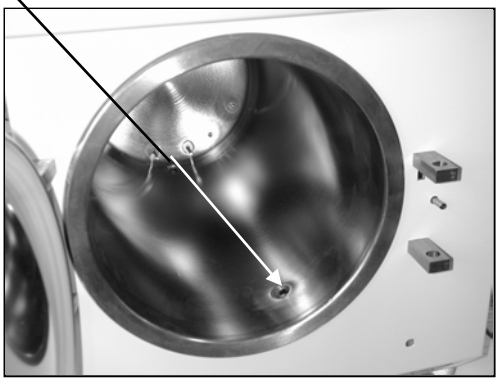
► The flow resistance in the intake line is too high

- Filter in the intake fitting on the sterilization chamber is clogged up

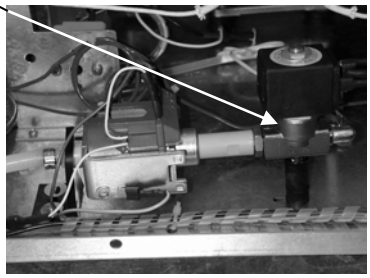
► The solenoid valve for the feed pump (VQ) has a leak
- Solenoid valve dirty. Check the plunger / is the seating tight?

Test under sub-atmospheric conditions (Vacuum Test program):
Observe the water column in the intake hose leading to the input of feed water between the conductivity-sensor and the intake fittings of the pump, and on the pressure side of the pump. If there is a leak, water will be pulled in the direction of the solenoid valve.

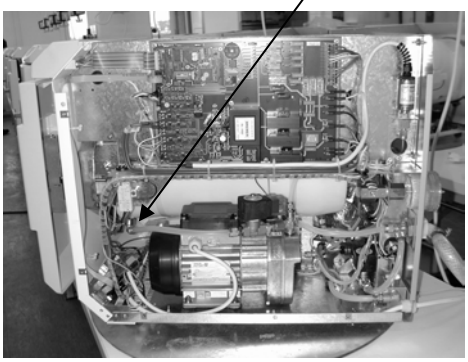
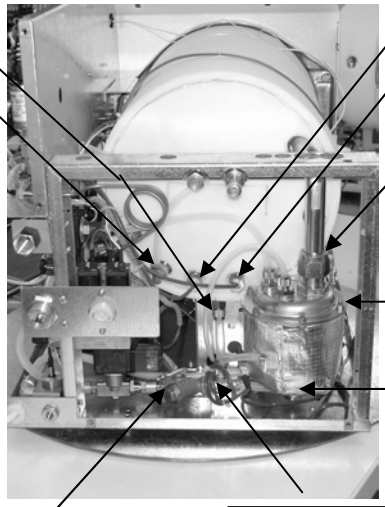
Leaks at the threaded connections and adhesive bonding

Adhesive-bonded threaded hose connections at the chamber

Threaded connections for temperature sensor

Cutting-ring threaded connection for steam generator / chamber

Cover seal for steam generator

Swivelled threaded connection for the steam generator

Plug of the pressure-release filter

Adhesive bond for the T-fitting in the pressure-release filter

Test under sub-atmospheric conditions: start the “Leak search” procedure in the Diagnosis Program (0.3 bar, for 8 min). Or, feed compressed air into the autoclave through the vent-filter fittings (in Diagnosis program, close output 8, “MV vent”). Brush a soapy solution on the points shown below and check to see if there are any air bubbles.

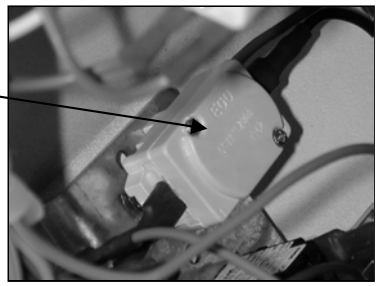
► Control steam generator Output ACOUT1 faulty

⇨ check in "Diagnosis Program":
Switch on ACOUT1, (the LED for this output lights up),
Measure voltage at output ACOUT1

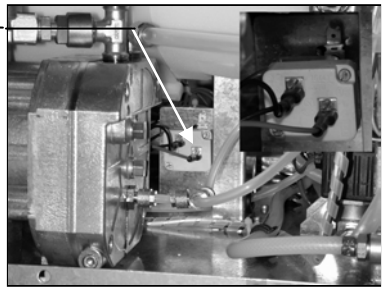
► Capillary level control unit faulty

- Control unit does not open on overheating (water shortage). Water shortage is not recognised and the overheating protection switch switches off.

⇨ Functional test of the capillary level control unit:
In the "Service Program“/ "switch-times" set z24 = 0,
Start Universal Program with full load, by switching capillary control unit and the resultant feed of distilled/demineralized feed water should compensate for the water shortage in the steam generator (observe condensation return to steam generator)

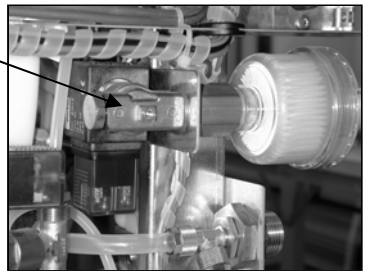
► Ventilation solenoid valve does not open

- Solenoid valve blocked mechanically (soiling)

⇨ Open valve casing, clean or exchange valve

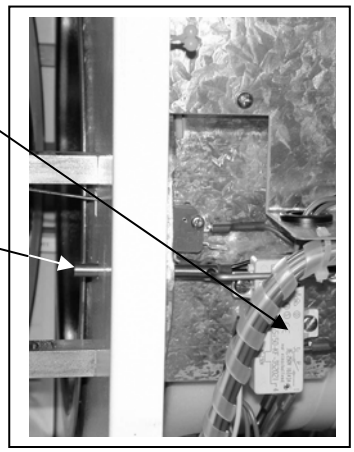
Adjusting the door lock

- Control for door locking output ACOUT 10 on CPU-board is faulty (permanent voltage)
- Contact switch on door lock is faulty
- Locking bolt cannot move freely / is blocked

- Dismantle door cladding, close door
- Loosen fixing screws on the door lock
- By shifting the door lock centralise the face of the locking bolt in the depression as shown, with a spacing of approx. 2 mm
- Tighten fixing screws on the door lock

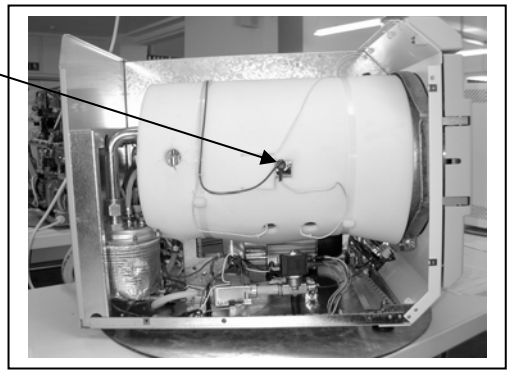
- Control unit permanently open
- Control unit switches too soon, and stops heating power:

⇨ Measure voltage behind the control unit during the program

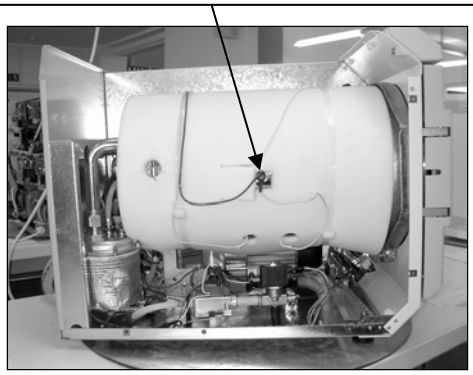
Temp.-sensor "Preheating" AIN4
Under the chamber insulation, stuck directly on the heating

► Temperature sensor Pre-heating faulty
⇨ Temp.-sensor Preheating measurements too high/fluctuating, in the "MELAG Diagnosis Program" check the analog input AIN4 during a program by pressing the button " - ".
Exchange temperature sensor

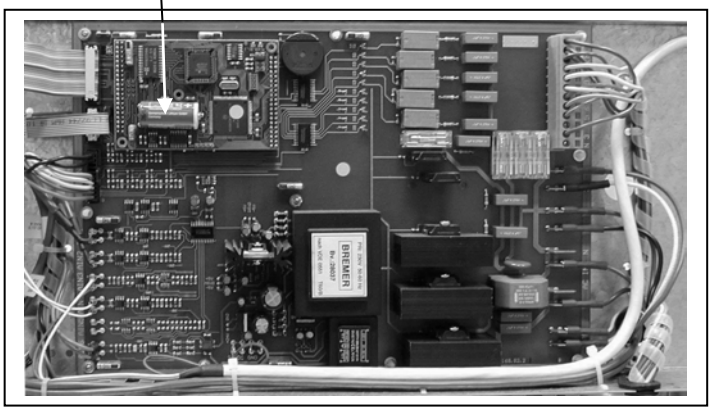
► Battery voltage too low

⇨ • If fault occurs regularly exchange battery on CPU- board (battery connections soldered)
